Toward Robust High Resolution Chemical Imaging

Carlos A. Barrios, Andrey V. Malkovskiy, Alexander Kisliuk, Alexei P. Sokolov, Mark D. Foster

Department of Polymer Science, The University of Akron, Akron, OH, 44325-3909

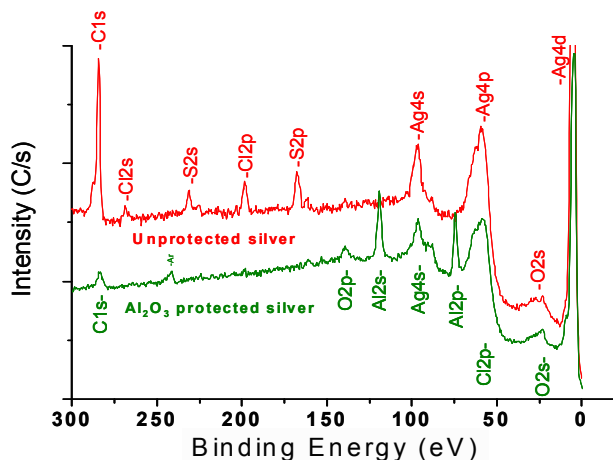
Figure 3. X-ray photoelectron spectra of silver plasmonic structures created on flat substrates after two months stored under ambient conditions: unprotected(upper curve) or protected by a 3nm thick ultrathin Al_2O_3 coating (lower curve). The lower concentrations of carbon, sulfur, and chlorine species evidence how the ultrathin Al_2O_3 layer drastically reduces chemical degradation.

The plasmonic/air interface is not only the heart of the plasmon resonance enhancement, but also the focus of the degradation. Two flat plasmonic surfaces prepared at the same time, but in different ways, one protected with a 3nm thick Al_2O_3 layer and the other unprotected, were used to determine how chemical degradation, principally generated by sulfur containing gases in the atmosphere and promoted by atmospheric humidity, is affected by the presence of the ultrathin Al_2O_3 layer. XPS spectra measured after 2 months of storage under ambient conditions show sulfidation, one of the main reactions of silver tarnishing, but also contamination of the unprotected tip by water, carbonaceous material and chlorine (Fig 3). The spectrum for the protected surface shows no sulfidation, no chlorine, and a lower concentration of carbon, evidencing how the ultrathin Al_2O_3 layer drastically minimized chemical degradation.
